Durofix RV332 Control Button Replacement

This guide will demonstrate how to properly replace a defective control button on a Durofix RV332 Cordless Li-ion Screwdriver.

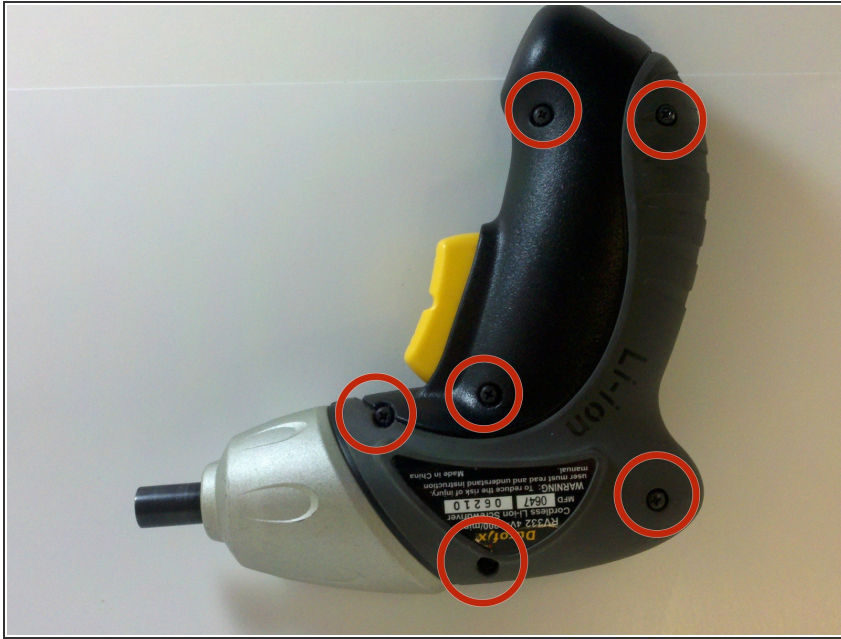
Step 1 — Control Button

- Remove the six 13 mm casing screws with a #0 Phillips screwdriver.

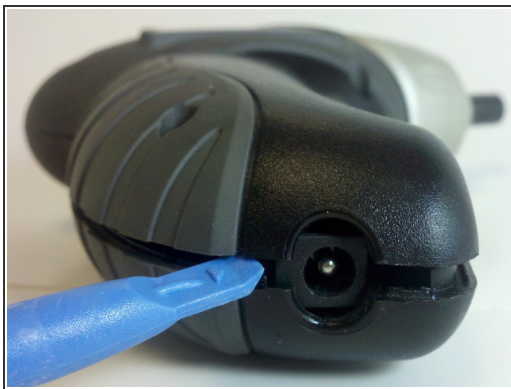
Step 2

- Separate screwdriver casing halves with a plastic opening tool.
